Subject: March 27, 2018 Inspection Report

**CWA COMPLIANCE EVALUATION INSPECTION REPORT
U.S. ENVIRONMENTAL PROTECTION AGENCY, REGION 5**

Compliance Evaluation Inspection

Ex. 6 (Personal Privacy) Farm

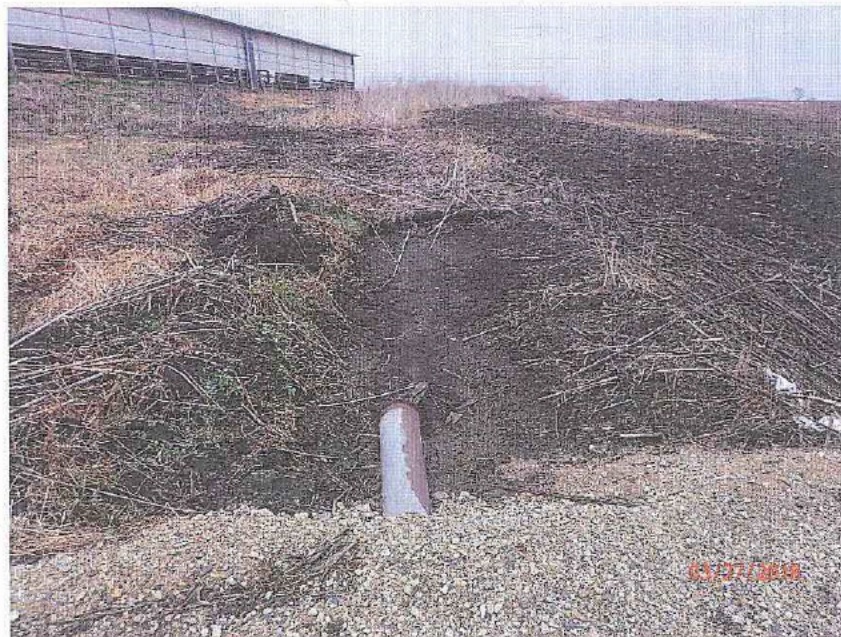
33: P3270049

Description: Storm water from fields flows under gravel driveway south of 2004 Freestall Barn.

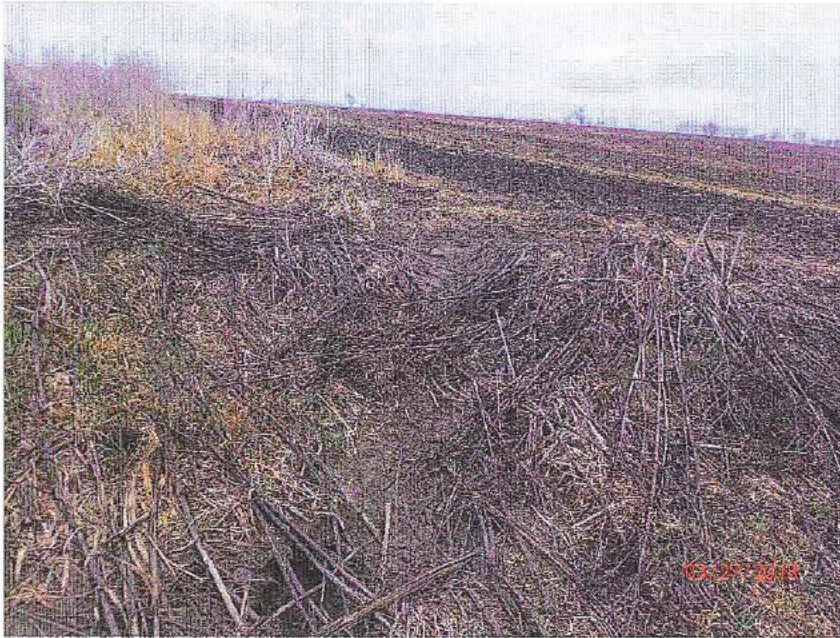
34: P3270050

Description: Owner reports very little flow in the storm water ditch since improvements were made at the facility.

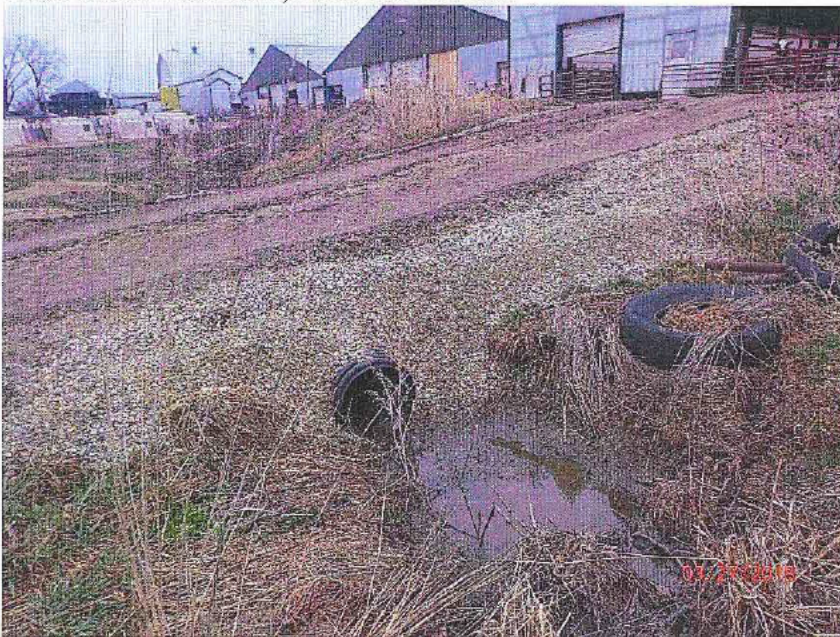
35: P3270051

Description: Flow from north into the storm water ditch goes through pipe under facility driveway.

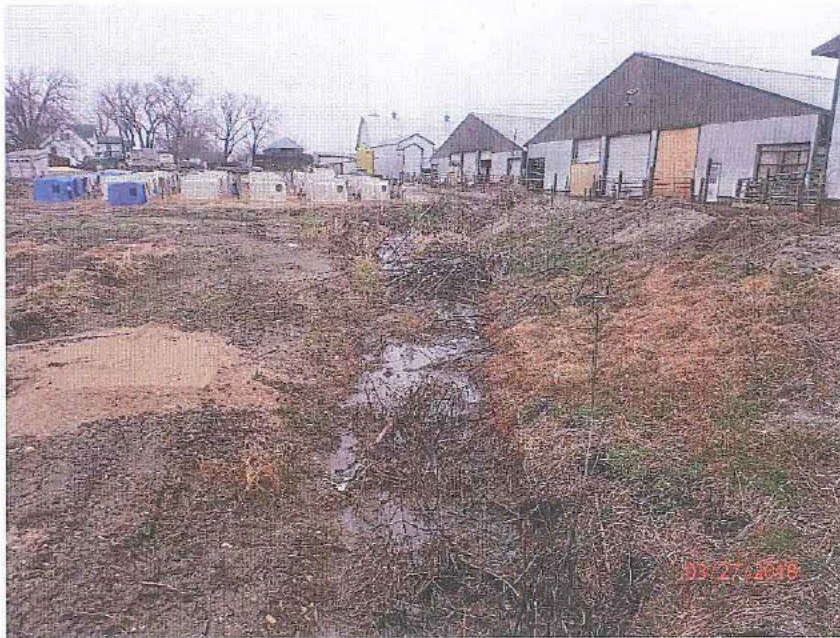
36: P3270052

Description: Storm water channel east of the Freestall Barns flows to the south.

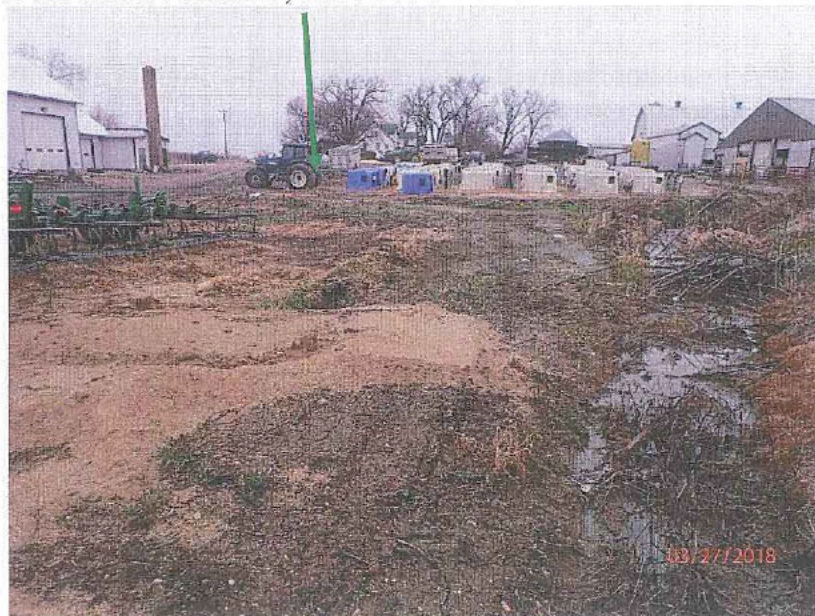
37: P3270053

Description: Depressional area for any runoff from haylage and feed and calf hutches is separated by a dirt berm from the storm water channel. Depressional area is denoted with a green arrow.

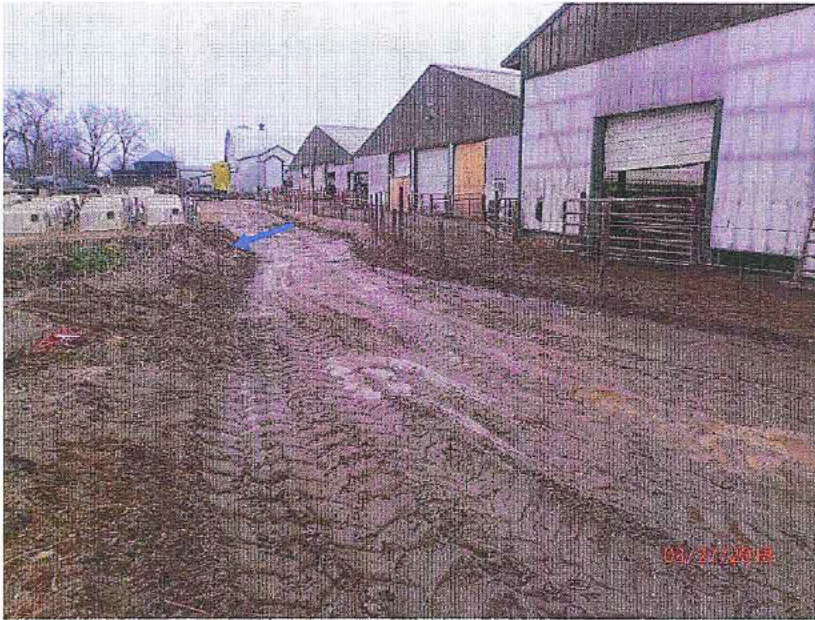
38: P3270054

Description: Lowest part of facility driveway is where the storm water channel that flows to the south begins and location of the storm water channel is denoted with a blue arrow.
